# San Fernando, California, Earthquake of February 9, 1971

LEONARD M. MURPHY  
*Scientific Coordinator*

*Volume I*

*Part B.* Buildings *continued*; Soils and Foundations

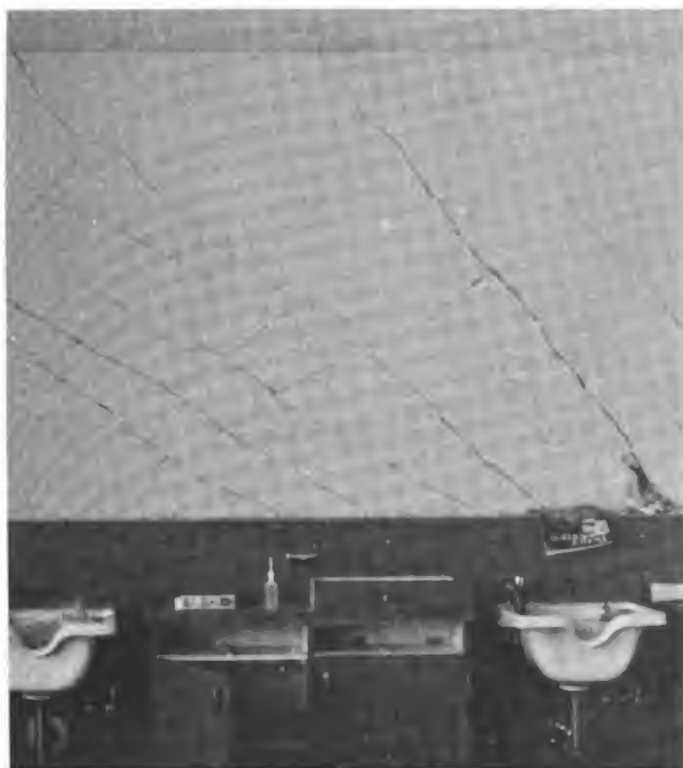
Above the second story, the lateral loads were resisted by the interior concrete shear walls (figs. 32 and 33) and the exterior concrete piers between the

Figure 33.—Olive View Hospital, medical treatment and care unit.  
Diagonal cracks in shear wall at second floor.

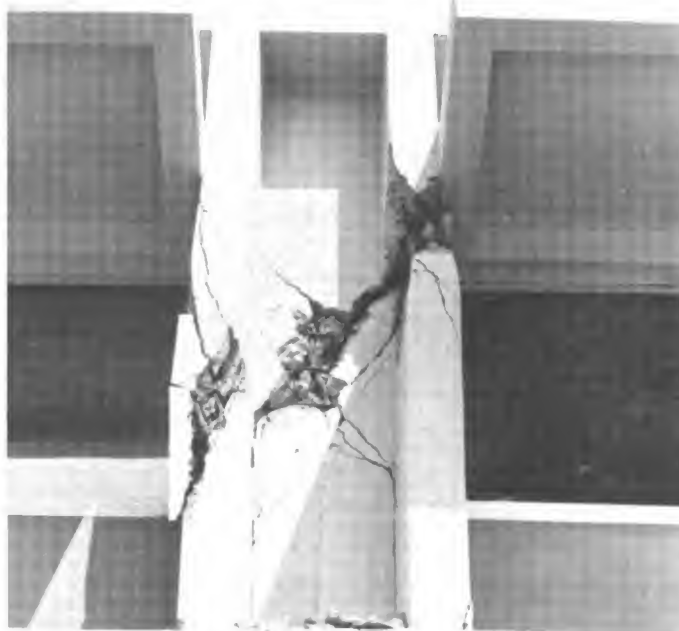
windows (figs. 24,F, 35, and 36). These members were stressed to capacity in shear. Their shear capacity was approximately twice that resulting from code forces.

Figure 35.—Olive View Hospital, medical treatment and care unit.  
Diagonal shear cracks in second-floor exterior wall panels viewed from outside.

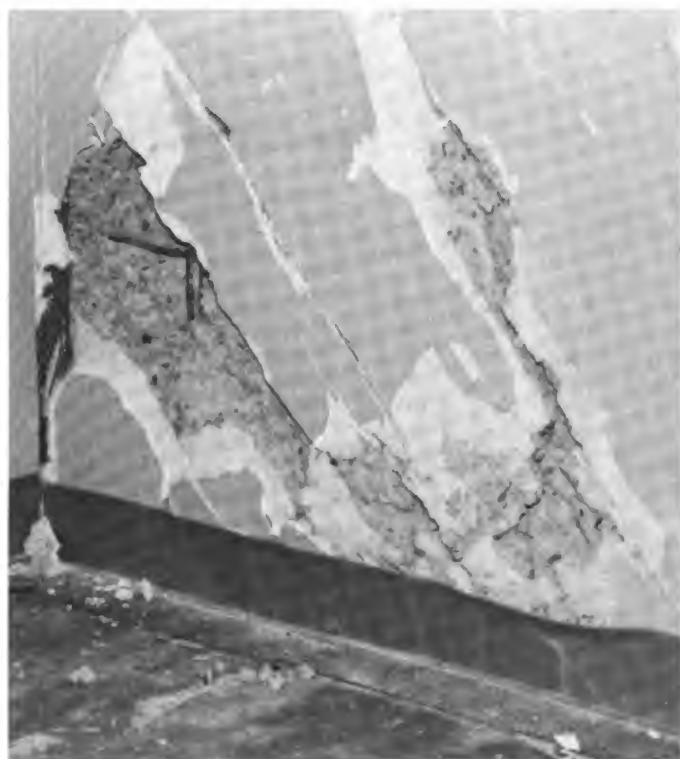
Figure 34.—Olive View Hospital, medical treatment and care unit.  
Diagonal cracks and spalling at floorline at wall shown in figure 33.

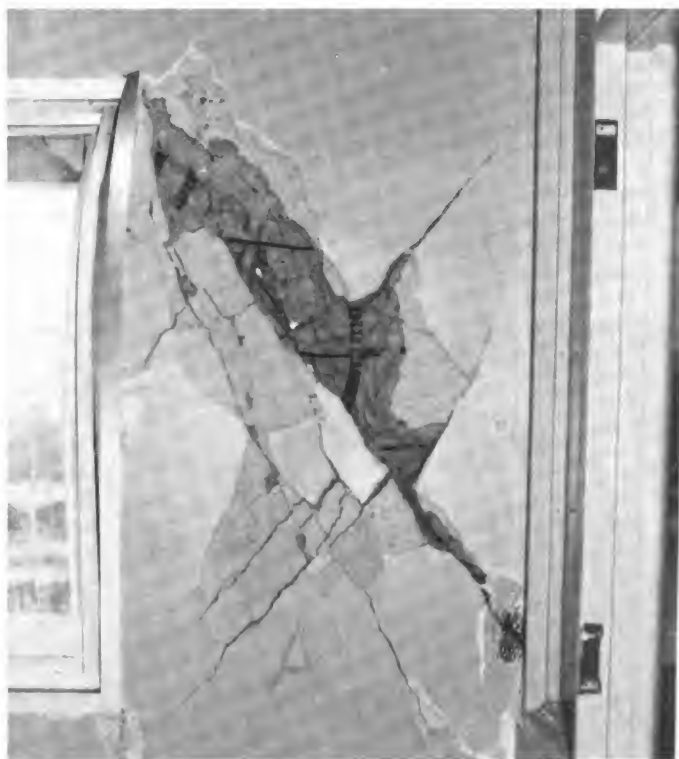
Figure 36.—Olive View Hospital, medical treatment and care unit.  
Diagonal cracks in figure 35 viewed from inside.

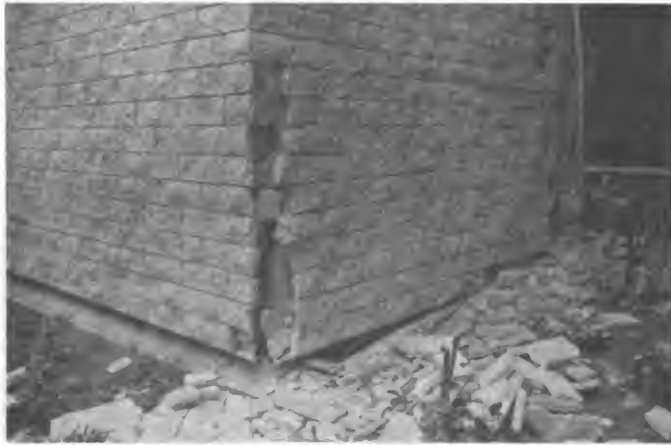
In addition to observed structural damage, there was considerable distress in the nonstructural features. In summary, nonstructural masonry walls were torn loose (figs. 11,B and 37); many precast concrete fascia elements were dislodged (figs. 38 and 39); walls collapsed (fig. 40); connections anchoring the precast concrete failed (figs. 41 and 42); interior partitions, ceilings, and other architectural features were damaged severely (fig. 43); and mechanical and electrical equipment failed to function.

**Figure 37.**—Olive View Hospital, medical treatment and care unit. Shift of southwest corner of east elevator at first-floor level. Wall was designed to be nonparticipating in resisting lateral loads and was separated from floor framing at this level.

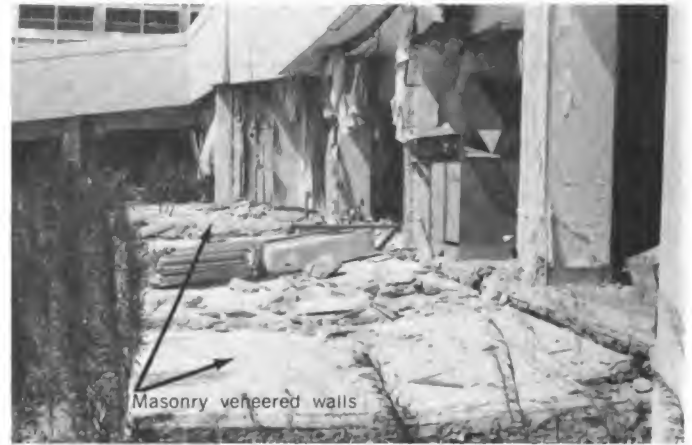
**Figure 40.**—Olive View Hospital, medical treatment and care unit. Masonry veneer walls lying on ground-floor level. These fell away from building due to earthquake movements.

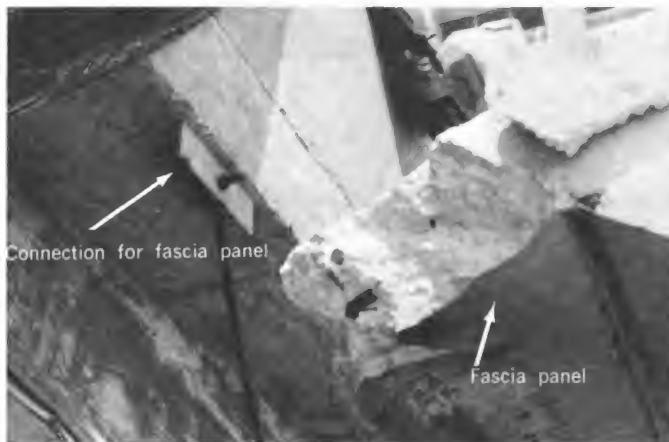
**Figure 38.**—Olive View Hospital, medical treatment and care unit. View from below of precast fascia panel connection to the concrete beams along first floor. View is at southwest corner of building.

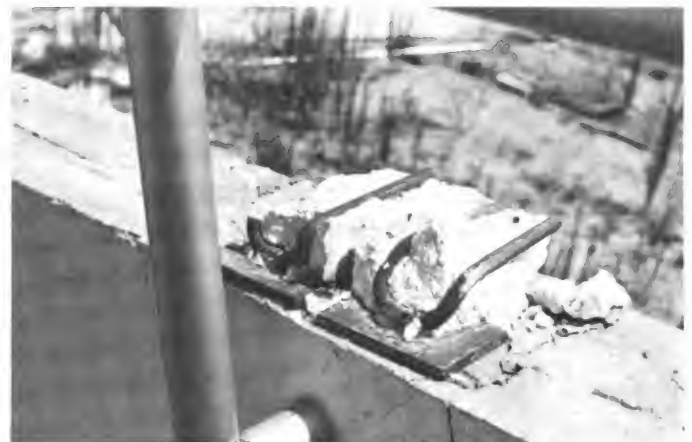
**Figure 41.**—Olive View Hospital, medical treatment and care unit. Upper connection of precast unit in figure 38 where failure occurred in precast unit concrete.

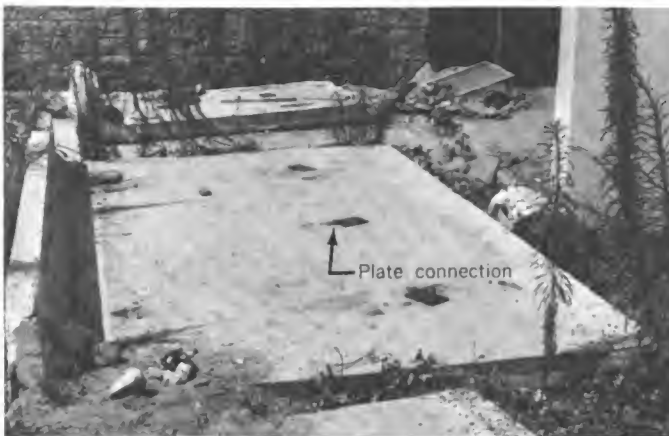
**Figure 39.**—Olive View Hospital, medical treatment and care unit. Precast units lying on ground. These were supported at first-floor level before earthquake.

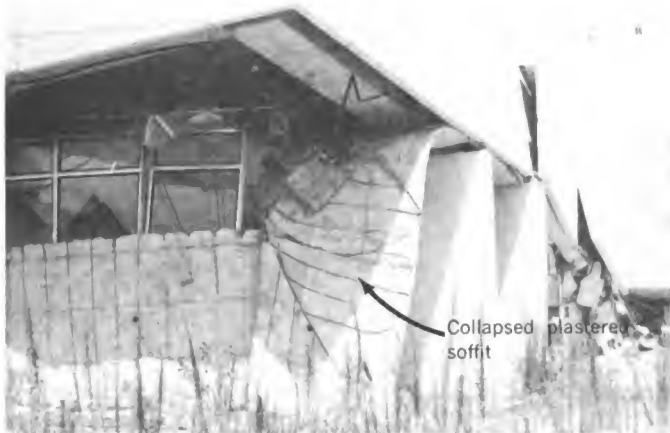
Figure 43.—Olive View Hospital, medical treatment and care unit. Ground-floor level framing at southwest corner which supports first-floor planting on roof. Note loss of plastered soffit and window wall damage from excess movement.

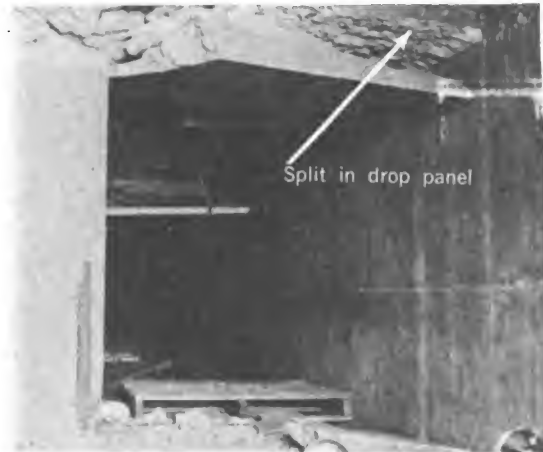
Figure 44.—Olive View Hospital, medical treatment and care unit. Distress to ground-floor flat slab drop panel adjacent to north wall. Some indication of uplift of north stair tower to retaining wall was indicated by splitting of drop panel area.

In the north stair tower, the south wall was anchored into the basement retaining wall (fig. 44), which was pounded by the side lurch of the main structure. Although this pounding contributed to the tilt of the tower (fig. 45), the main cause was the failure of the columns under the north wall (figs. 46, 47, and 48). The bearing of the grade beams and the grade slab against the soil sustained the tower from overturning.

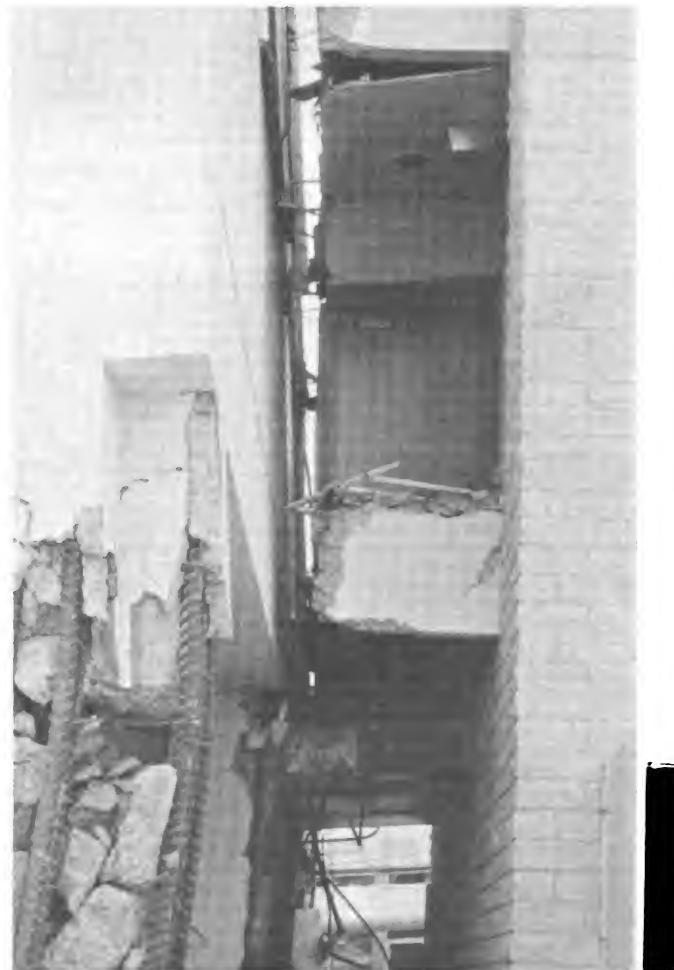
Figure 45.—Olive View Hospital, medical treatment and care unit. Tilt of north stair tower from building viewed from ground-floor level.

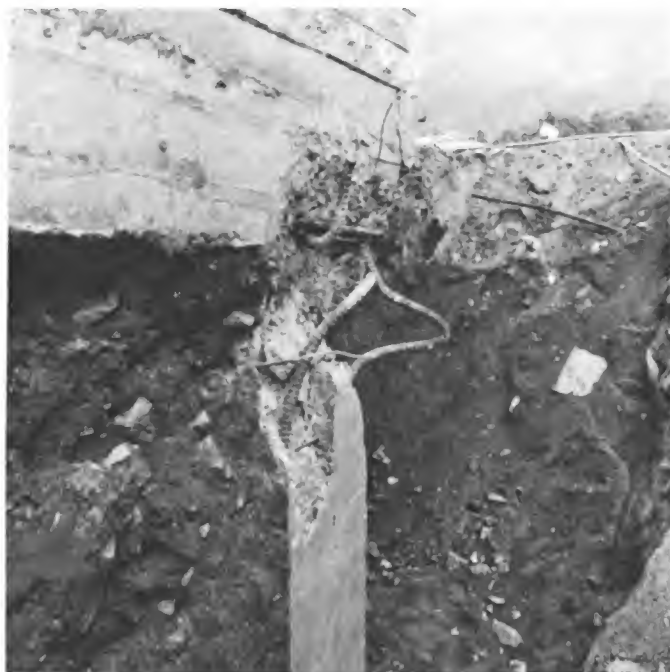
Figure 46.—Olive View Hospital, medical treatment and care unit. Northwest corner of north stair tower below first-floor ground level. Note complete collapse of tied concrete column below grade beam. LeRoy Crandall & Associates photograph.

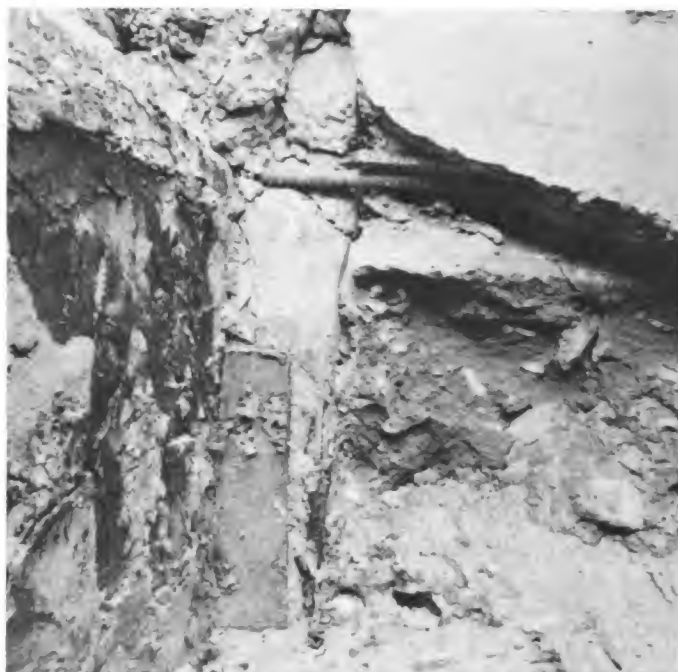
Figure 48.—Olive View Hospital, medical treatment and care unit. Southeast connection of north stair tower to basement retaining wall at left side of photo. LeRoy Crandall & Associates photograph.

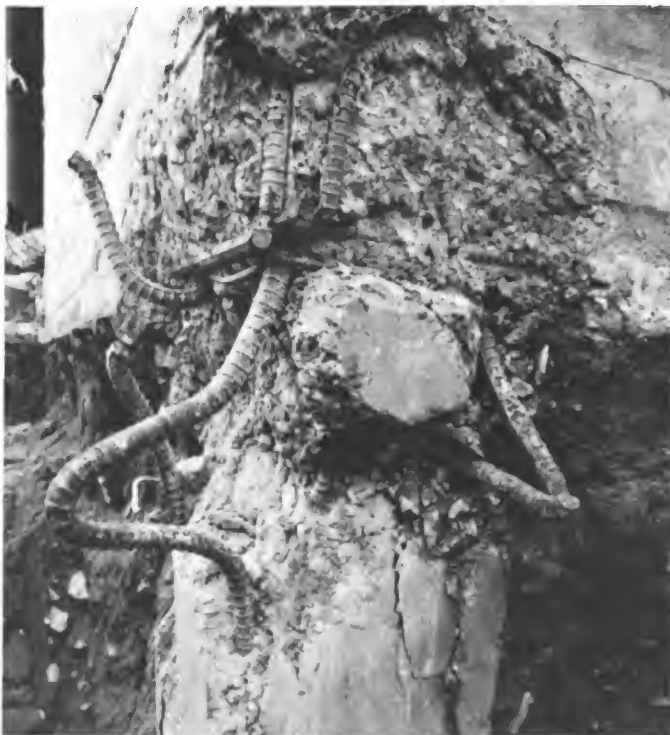
Figure 47.—Olive View Hospital, medical treatment and care unit. Northeast corner of north stair tower with close view of column collapse. LeRoy Crandall & Associates photograph.

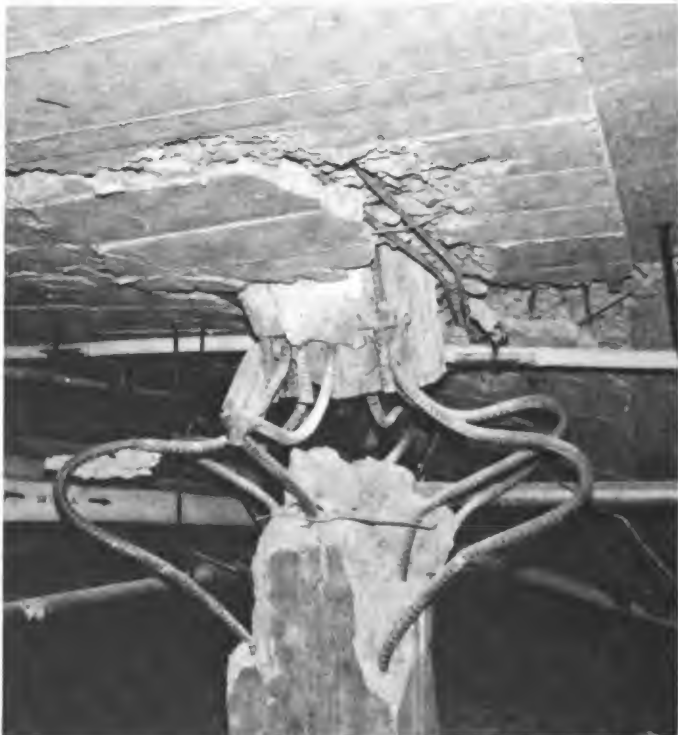
Figure 49.—Olive View Hospital, medical treatment and care unit. Collapse of southeast column of west stair tower in pipe space below ground floor. Tied column was separated from ground-floor slab in design.

The other towers overturned because the supporting column and beam structure in the lower story failed, probably in shear. In the west tower the column failed, as observed in the pipe space below the ground-floor level (fig. 49). Inadequate confinement and low shear capacity are evident in this column.

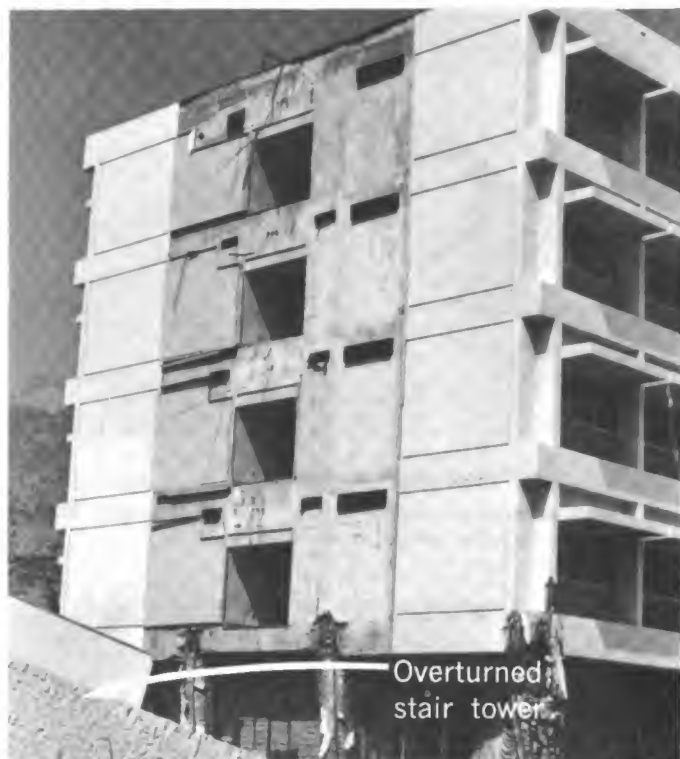
Figure 50.—Olive View Hospital, medical treatment and care unit. South end view of south wing with stair tower in its overturned position.

In the collapsed south tower (figs. 50 and 51), there were other contributing factors. The columns were offset from the corners and interrupted the anchorage of the continuous column steel.

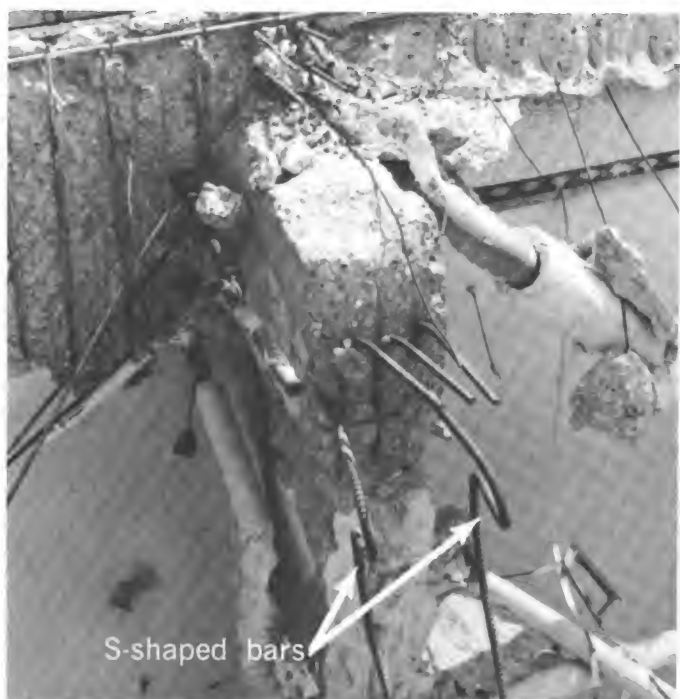
Figure 51.—Olive View Hospital, medical treatment and care unit. Bottom view of south stair tower with first-floor framing shown intact. Note the S-shaped column bars which extended to foundation.

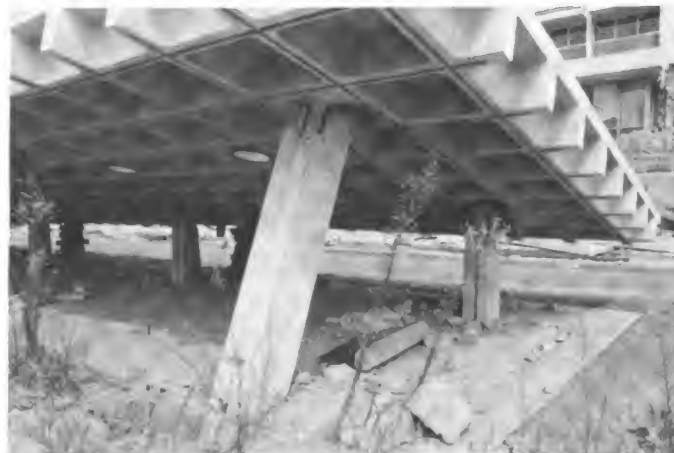
Figure 52.—Olive View Hospital, ambulance canopy. View looking north, showing collapse of north tied columns and subsequent rotation at south column line.

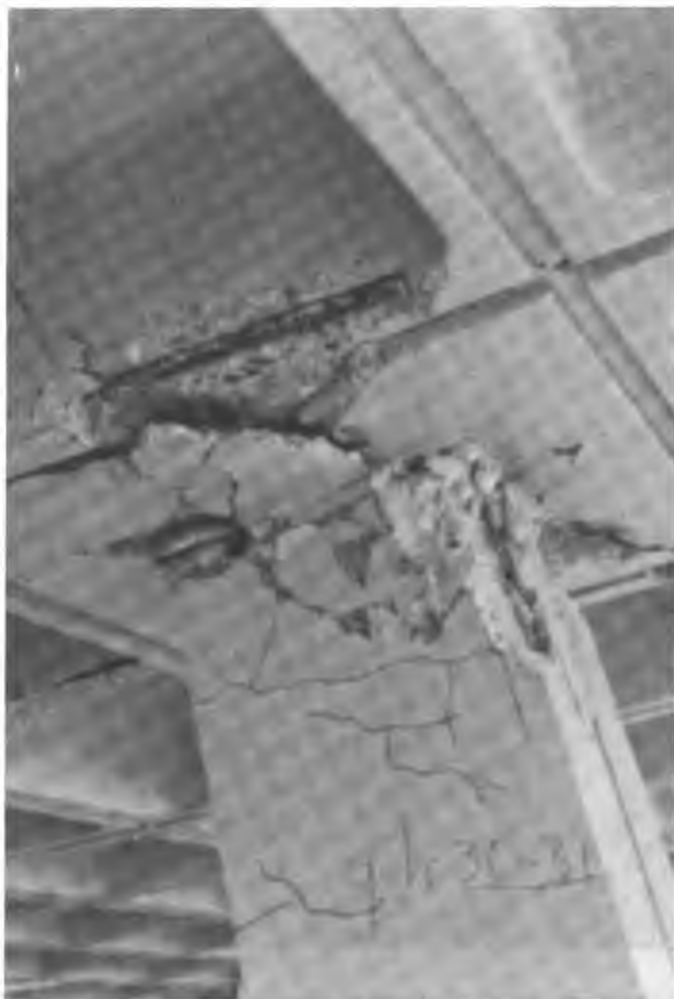
Figure 53.—Olive View Hospital, ambulance canopy. Closeup view of south column upper connection to roof framing.

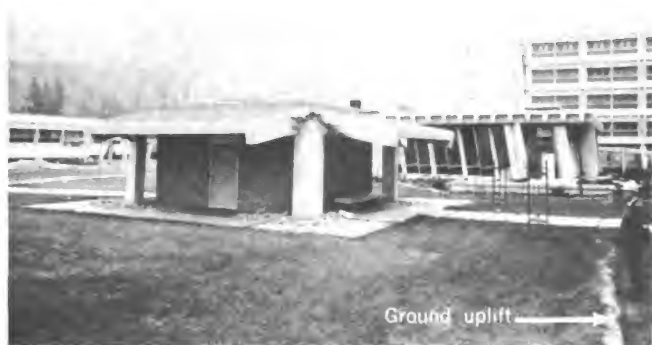
Figure 55.—Olive View Hospital, exhaust building. View looking northeast, with assembly building and north stair tower in background. Note ground uplift (at right of photo) as result of basement wall movement.

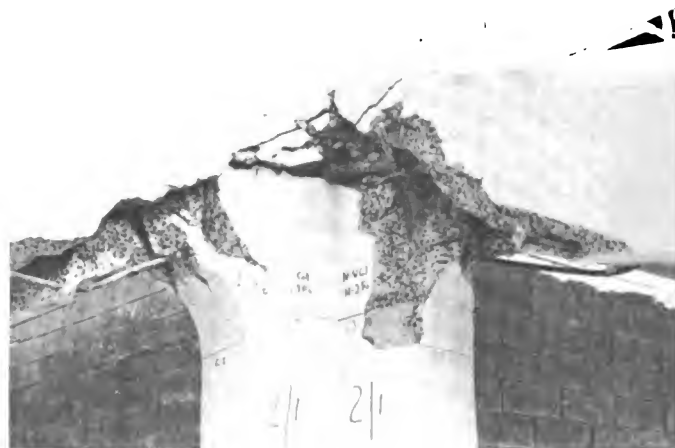
Figure 56.—Olive View Hospital, exhaust building. View of roof-to-column connection, indicating the loss of resistance due to lack of anchorage for column reinforcing bars.

The damage to the structure was primarily in the cantilever girders (figs. 56 and 57) and, particularly, in the beam-column joint. The vertical column steel lacked the proper end anchorage to resist the induced bending moment caused by lateral deformations.

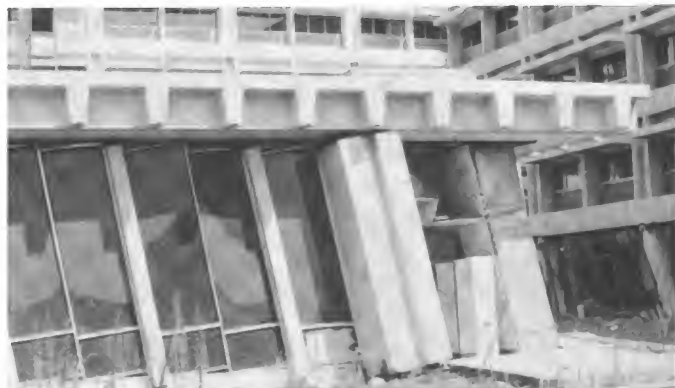
Figure 58.—Olive View Hospital, assembly building. Southwest corner vertical cantilever column supporting roof framing. Column is fixed below the first-floor ground level and is connected at roof as shown in figure 59.

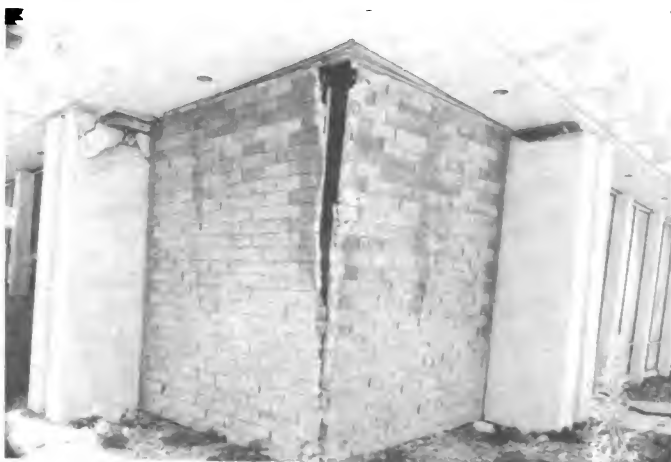
Figure 60.—Olive View Hospital, assembly building. Distortion and cracking of nonbearing masonry walls at northeast corner. Note damage of roof-to-column connection.

The building suffered serious damage. It is evident (fig. 63) that the columns are out of plumb as much as 24 inches. Close examination reveals that the vertical column steel has yielded from severe over-stress and taken a permanent set. The window wall sections, the slip joints at the tops of the columns, and many other elements (figs. 60, 61, and 62) could not resist the strain imposed by the large lateral deformation.

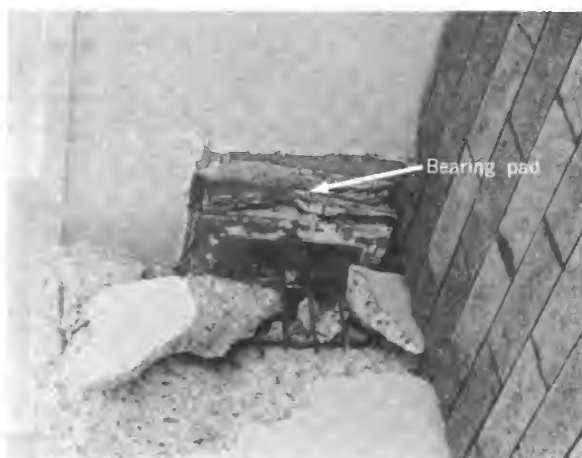
Figure 61.—Olive View Hospital, assembly building. Closeup view of recessed roof connection to column. Note bearing pads.

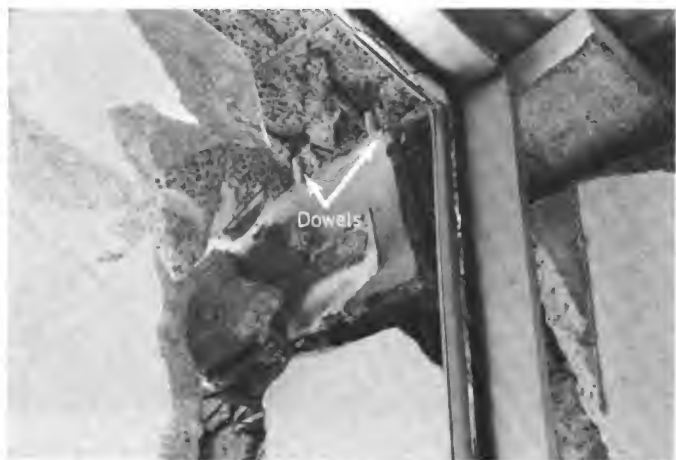
Figure 62.—Olive View Hospital, assembly building. Closeup view of recessed roof connection, showing failure of dowels into roof slab due to lack of anchorage.

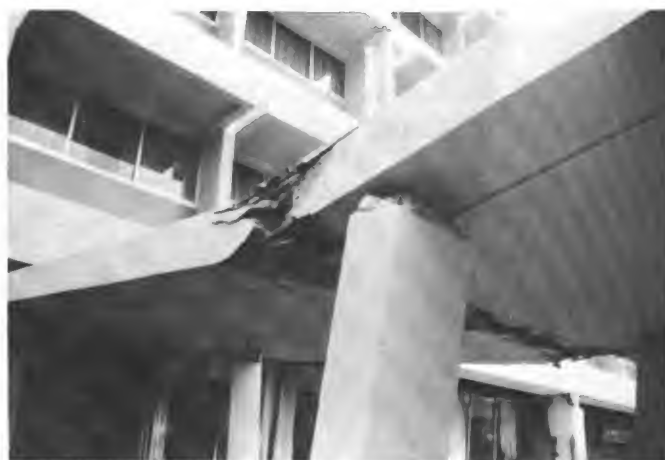
Figure 64.—Olive View Hospital, walkway canopy. View of south end where the cantilevered roof cracked due to movement between medical and psychiatric buildings.

The structure did not collapse fully, but considerable damage resulted from vertical ground deformation of the north ground floor of the medical treatment and care unit. This tilting caused the roof slabs to pull away from the top of the column reinforcing due to lack of anchorage (fig. 64). At the other end of the walkway at the psychiatric unit, the cantilever end of the canopy probably was broken when this building collapsed (figs. 65 and 66).

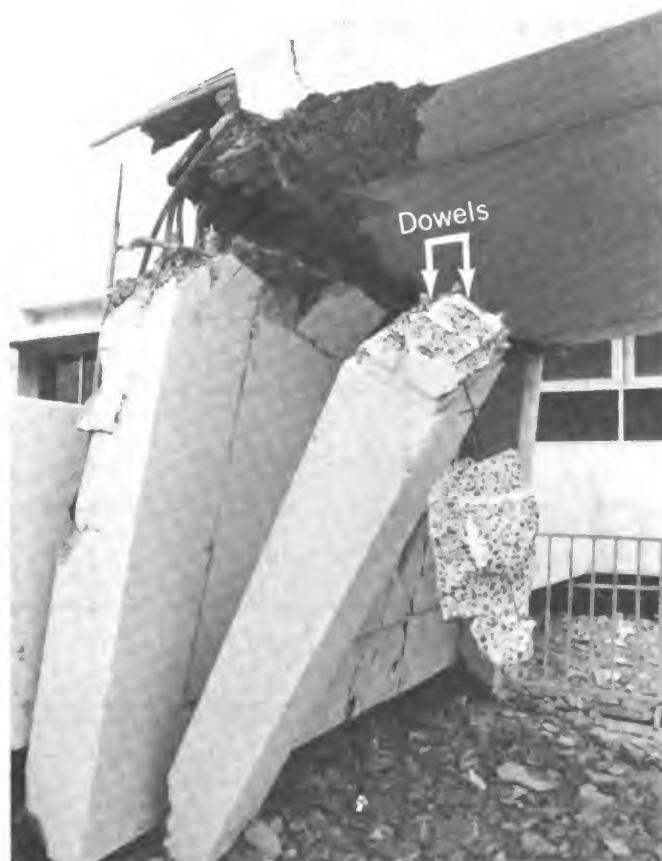
Figure 66.—Olive View Hospital, walkway canopy. Separation of roof slab from top of column. Note lack of anchorage of column bars into slab.

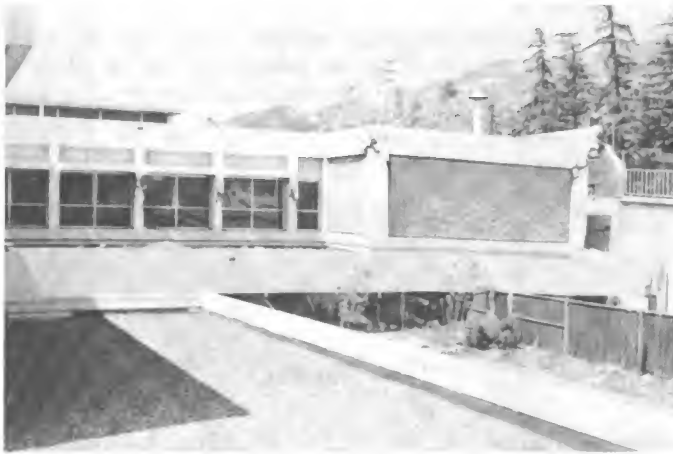
Figure 71.—Olive View Hospital, psychiatric unit. Second-floor view of northeast corner, showing distress to concrete columns and beams around nonshear resisting walls. This building collapsed completely at lower story.

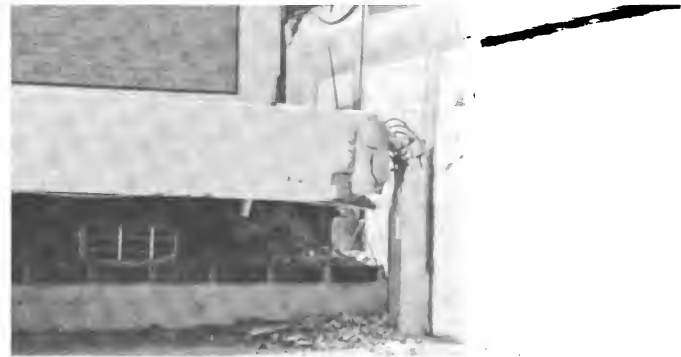
Figure 73.—Olive View Hospital, psychiatric unit. View of northeast corner where the building separated from north retaining wall. Note cracks in wall and position of beam at left relative to its original position next to retaining wall.

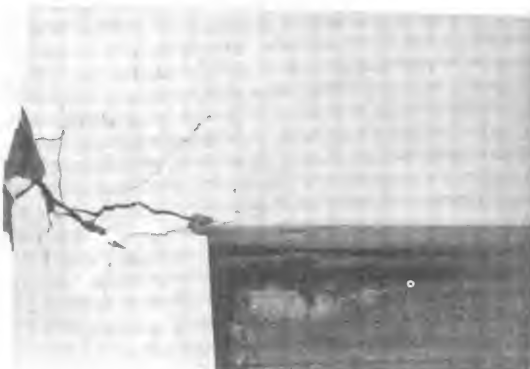
Figure 72.—Olive View Hospital, psychiatric unit. Closeup view of beam-to-column connection.

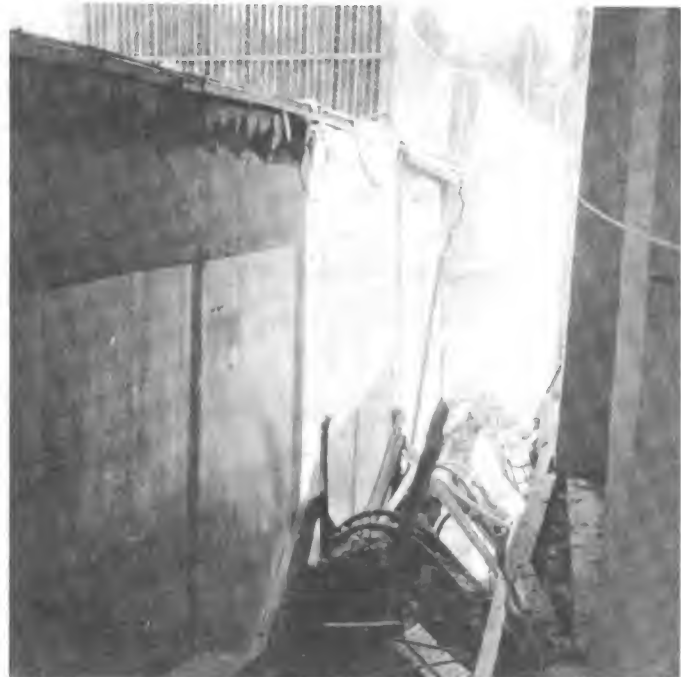
Figure 74.—Olive View Hospital, psychiatric unit. Interior view of north wall, looking east. Floor at right was originally at top of wall.

The first-story frames failed as a result of column shear failures caused by the large second-floor deflections and resulting high moments (fig. 73). Inadequate column ties to resist the shear forces is probably the major cause of the failures. The ends of the column ties were bent typically through  $135^\circ$ . When the concrete shattered, the ties became disengaged. The participation of the block walls at the first story as lateral-resisting elements was minor, since only a few walls were at this story and many of them had large openings at their ends. The retaining wall added no lateral resistance as the building moved away from it (fig. 74).

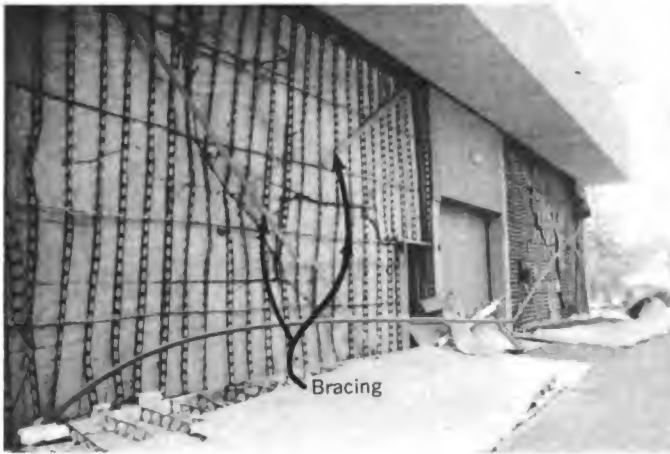
Figure 76.—Olive View Hospital, heating and refrigeration plant. View of north wall, showing failure of diagonal bracing straps and plastered stud wall on ground.

Damage to the building started with the diagonal straps in the north wall, stretching well into the yield range. The elongated straps permitted a large deformation to occur in the building before the straps became effective in resisting further motions (figs. 76 and 77). With the bracing ineffective, high torsional loads, in addition to direct lateral loads, were induced into the roof decking and side shear walls.

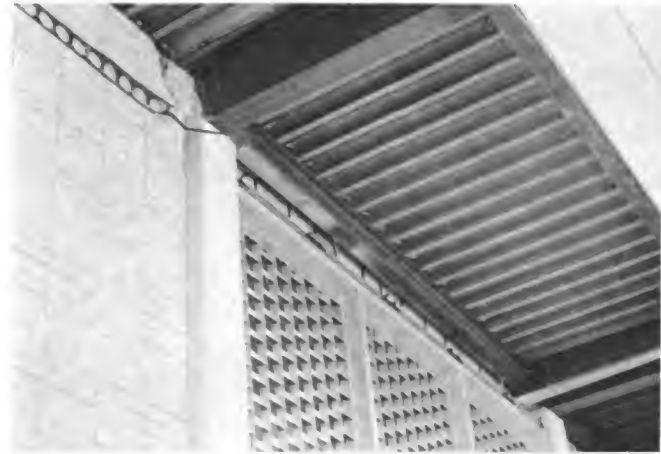
Figure 78.—Olive View Hospital, heating and refrigeration plant. Distress to upper column connection of beam and wall on east side. Note loss of ceiling below roof deck.

The high lateral loads and induced torsion caused strut loads at the east and west sides that, according to calculations, exceeded the design loads by 250 percent. These strut loads were carried by steel beams to anchors embedded in the top of the east and west block walls (figs. 78 through 80). The cracks in the wall resulting from the high strut loads are shown in figure 81. There was some uplift at the columns at the ends of these block walls, but this force did not appear to be excessive.

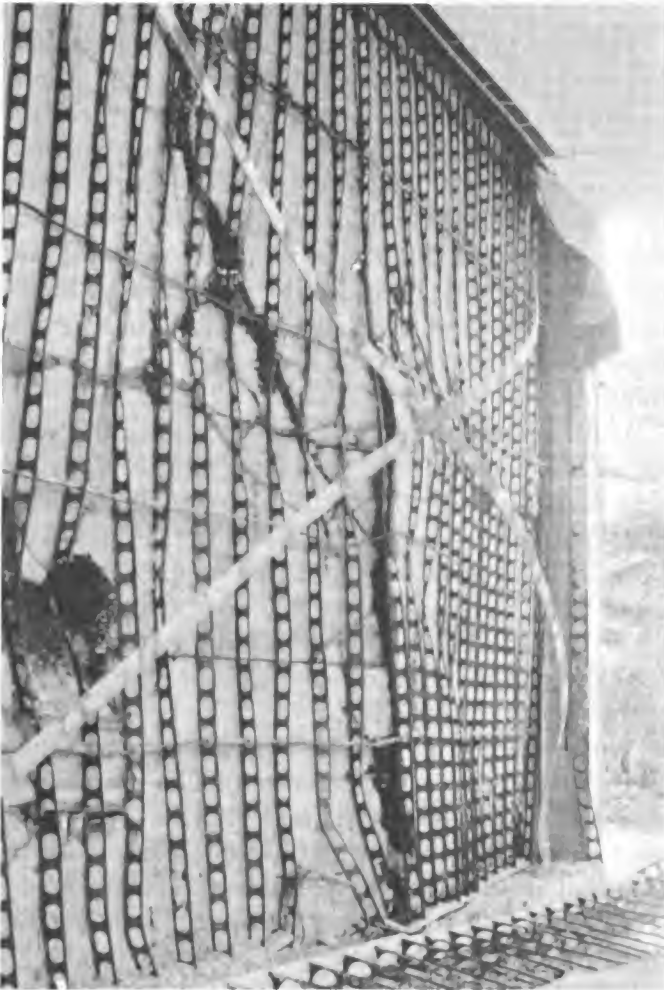
Figure 77.—Olive View Hospital, heating and refrigeration plant. Excessive deformation of diagonal bracing shown in figure 76. Vertical crack in plaster wall was caused by shifting of equipment within the building, as seen in figure 84.

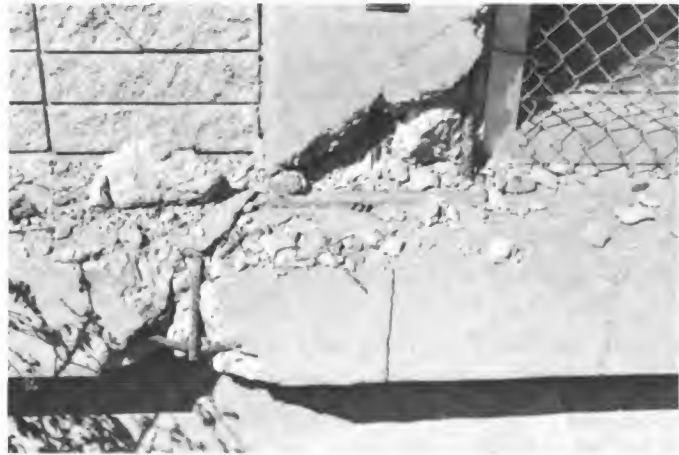
Figure 79.—Olive View Hospital, heating and refrigeration plant. Distress to lower column connection of figure 78.

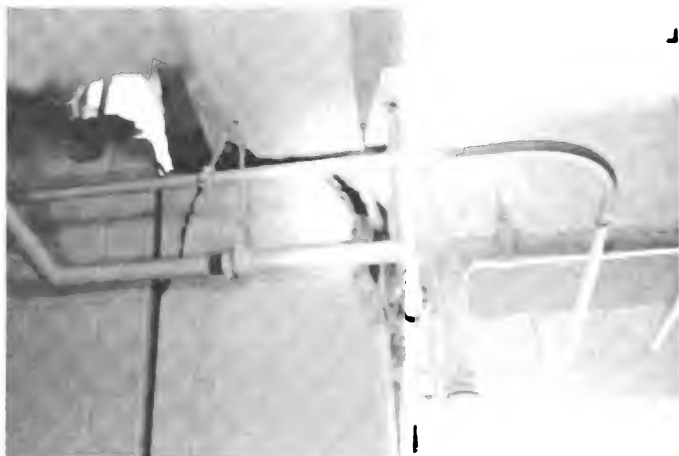
Figure 80.—Olive View Hospital, heating and refrigeration plant. Distress to upper column connection at west side.

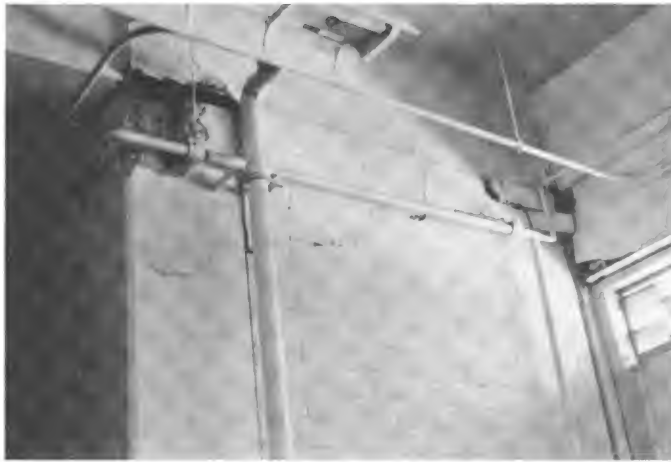
Figure 81.—Olive View Hospital, heating and refrigeration plant. Cracking in masonry wall and concrete column at west side of column shown in figure 80.

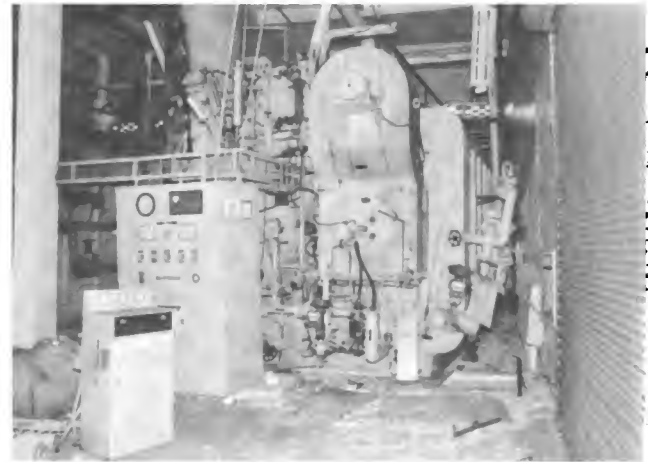
Figure 84.—Olive View Hospital, heating and refrigeration plant. Boiler final location against north wall.

Another area of damage of major proportions involved many heavy pieces of inadequately anchored equipment, which moved along the floor. In some cases, this movement produced damage to walls or piping (figs. 83 and 84).

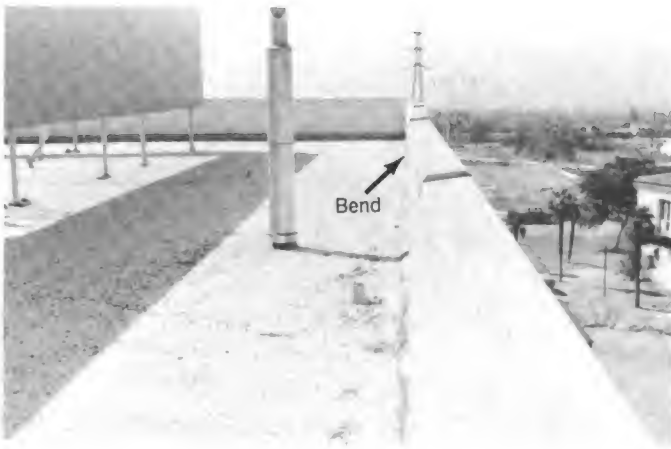
Figure 82.—Olive View Hospital, heating and refrigeration plant. Distortion of west parapet.

In figure 82, some buckling can be seen to have occurred at the west parapet. It also was observed that diagonal stress patterns occurred in the roof at the west side which indicates probable buckling in the steel decking under the roofing material.

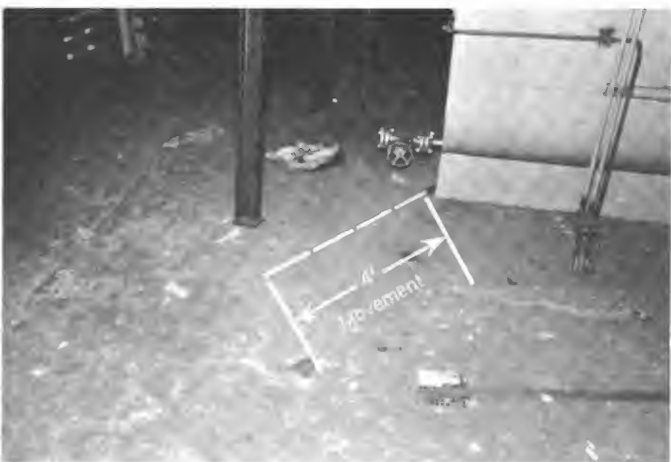
Figure 83.—Olive View Hospital, heating and refrigeration plant. Final location of boiler on floor near west wall. Total movement was about 4 feet.

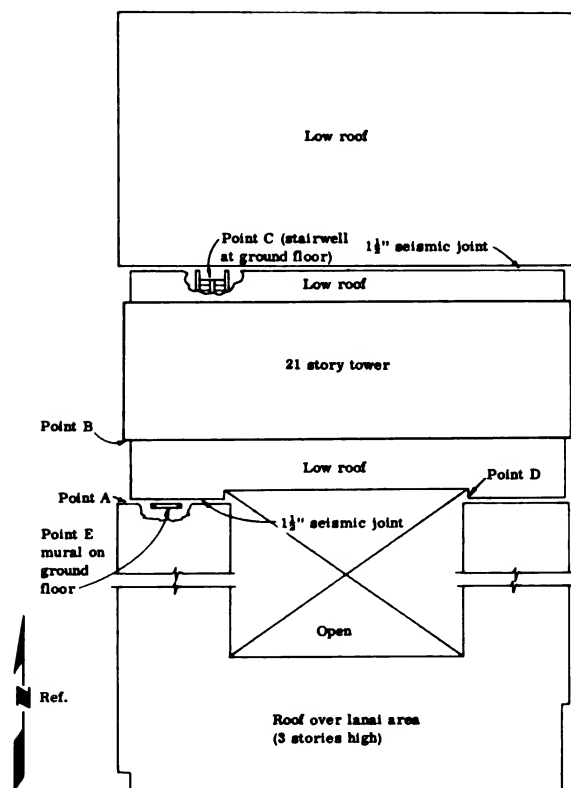
Figure 10.—Sheraton-Universal Hotel. Key plan of building showing location of damage.

floor at the west end. This band of cracking consisted primarily of diagonal cracks from the upper corners of the doors to the ceilings in the east-west filler walls on column lines 22 and 25. These walls, 2-inch laminated gypsum wallboard partitions, apparently were secured on all four edges. The major wall cracking was concentrated between the ninth and 11th floors.

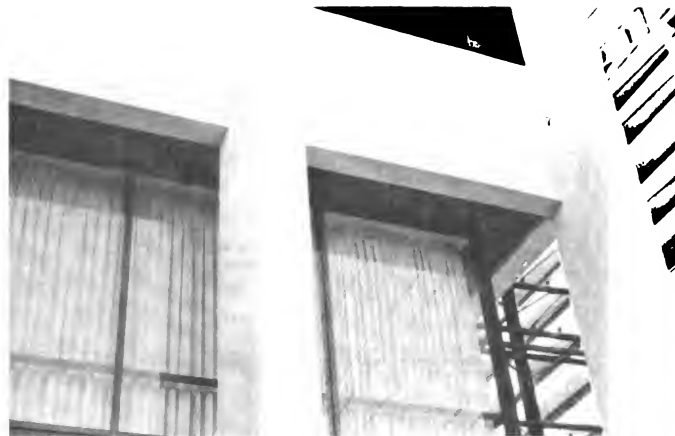
Generally, visible structural damage was slight and consisted almost entirely of minor cracking and spalling of concrete (figs. 10 and 11). However, in some areas, extensive cracking occurred, particularly at the exposed girder stubs at the exterior columns along the second-floor level (figs. 12 and 13).

Figure 10.—Bank of California. Spalling of paint surface at northeast corner column (third-floor) cold joint. Only hairline cracks were observed in the joint area. Brandow & Johnston photograph.

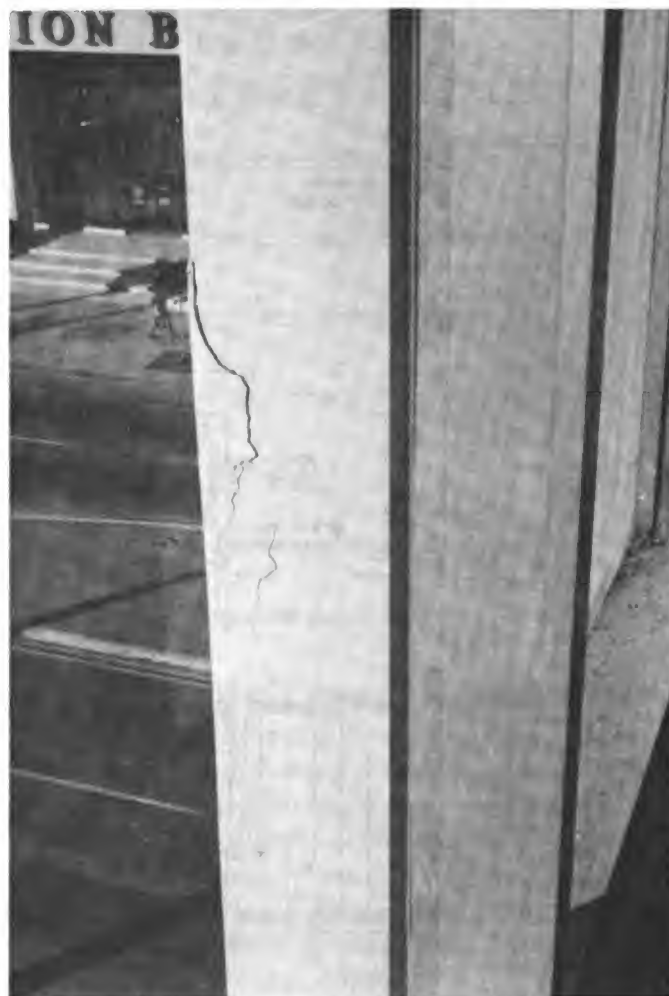
Figure 11.—Bank of California. Spalling of concrete at northwest corner column, fourth floor. This condition, which did not occur at any other location, may have resulted from a defective concrete patch during construction. Brandow & Johnston photograph.

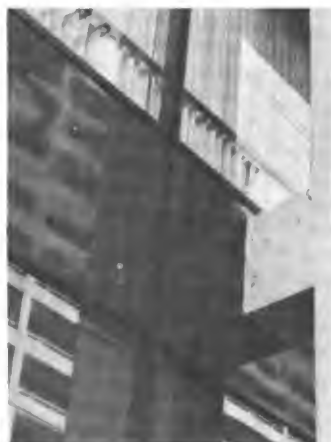
At the second floor, girders projecting beyond the spandrel line were damaged. The parapet on the one-story low roof structure attached to the main building also was damaged. The torsion induced in girder stubs projecting from columns on the north and south sides caused cracking as shown in figures 12 and 13. The stubs are located at alternate columns, except at corners, and for the north and south sides were not considered seismic force-resisting elements. Girder stubs on the west side also showed some bending cracks.

Figure 12.—Bank of California. Exterior second-floor girder-column joint in nonseismic north-south frame. Note that spandrel beam, which lies hidden behind curtain wall, is considerably offset from column centerline. John A. Blume & Associates photograph.

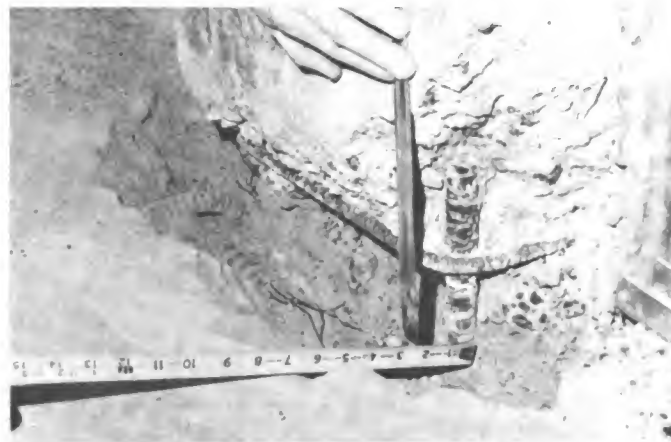
At floor level on the third, fourth, and fifth floors, exterior columns typically spalled (figs. 14 and 15). On the east and west sides of the building, spalling also occurred at the top of the columns, but only on the interior column face. On the east and west sides, some spandrels showed areas of spalling near the columns.

Figure 15.—Bank of California. Detail of spalled and chipped area similar to that shown in figure 14. Note that top joist reinforcement was terminated by hooks at column face and was not extended into confined area of column. Brandow & Johnston photograph.

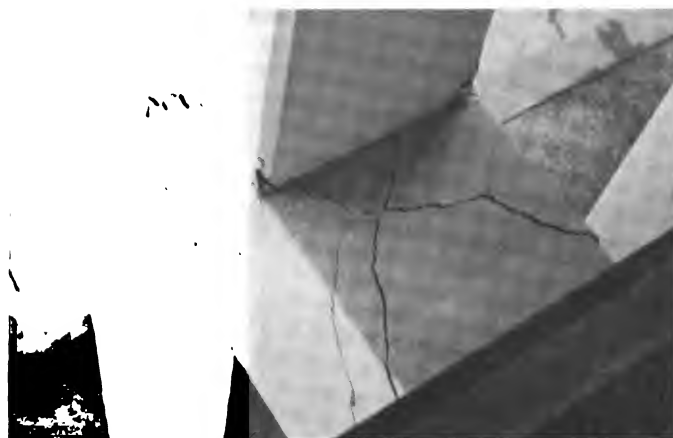
Figure 13.—Bank of California. Top view of second-floor girder-column connection shown in figure 12. Evidence of torsional cracking resulting from offset spandrels is apparent. Brandow & Johnston photograph.

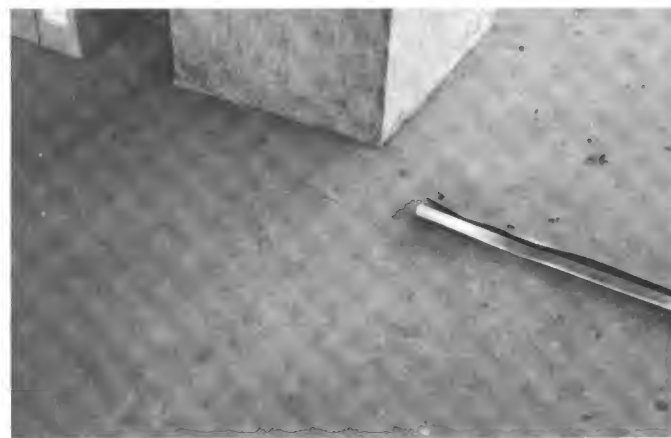
At these same levels, interior columns experienced no damage, but a series of cracks was observed in the floor slab around columns (fig. 16). Corner columns revealed some hairline cracks on a slight diagonal ex-

Figure 16.—Bank of California. Type of floor and girder cracking found near second interior column, in from north end of the building on both fourth and fifth floors. Brandow & Johnston photograph.

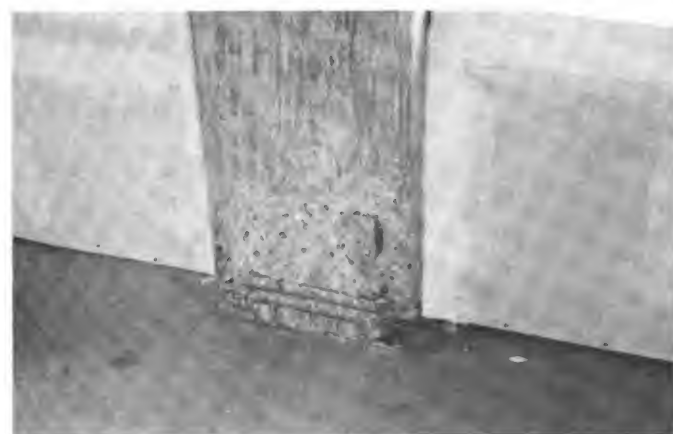
Figure 14.—Bank of California. Spalled area on interior face of exterior column. Column reinforcing has been further exposed by chipping. Brandow & Johnston photograph.

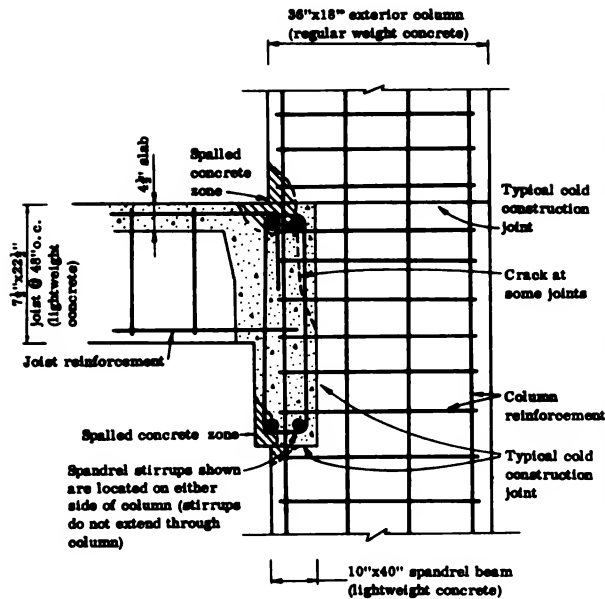
The spandrel-column detail shown in figure 18 facilitated construction (concrete pours) from the fourth floor to the roof. Major joint rotation and column or spandrel spalling coincided with areas where this detail was used (figs. 19, 20, and 21).

Figure 18.—Bank of California. Typical construction of exterior column-spandrel-joint connection from fourth floor to roof.
